STEP 1: DETERMINATION OF SIGNIFICANCE
STAFF REPORT

Site: 8 Medford Street

Case: HPC.DMO 2020-24

Proposal: *Demolish principal structure.*

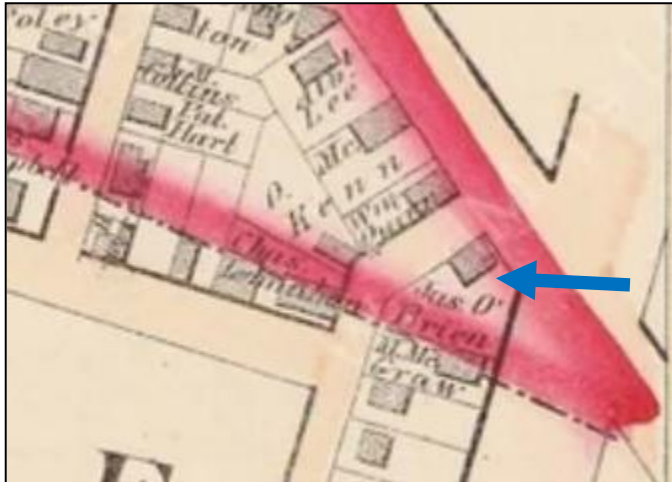
A close-up of this same 1874 Hopkins Plate F below shows that the parcel was owned by a James. O'Brien. At the time, this property had a Warren Street address (Warren Street being the street running immediately to the left of the property and intersecting with Medford/South Streets). Note the Boynton Packing Company on the Somerville side of the map, abutting the Fitchburg Railroad.

Left: Today's 8 Medford Street. Given the shape and location of the structure, Preservation Planning believes that it is the same structure that is present today.

- a. Location: Based on map research, it is believed that the structure is in its original location
- a. Design: Three-story with flat roof. Square form. Deeply inset raised entry on the left front of the building. Interior clapboarding on inset entry.

- c. Materials: Wood frame; vinyl siding; vinyl windows; brick facing at street-level on front and right facades. Brick and concrete steps.
- d. Alterations: The property has been extensively altered. Windows have been closed up, brick facing and vinyl siding added and the original steps removed. All windows are modern day replacements. While most windows are double-hung, others are small, modern sliders.
